Gold King Bond Forfeiture M-1986-013

Phase I 2008 Permanent Portal Discharge Diversion Structure

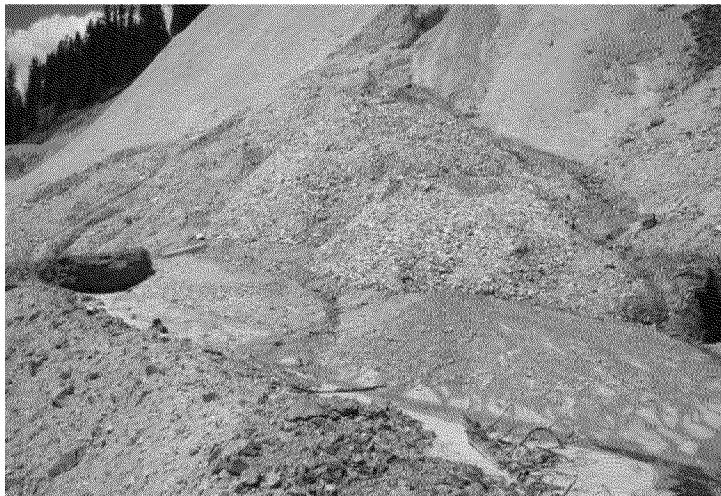
Gold King Permanent Portal Discharge Diversion Structure

The project was constructed during the week of August 25, 2008. The new permanent portal discharge diversion structure was excavated into the top of the mine waste and 165 foot of half round 36" diameter corrugated pipe was set at a 2-3% grade.

In 2008, DRMS took action and halted the saturation of the Level 7 mine waste pile. DRMS met with Todd Hennis, landowner, and settled on moving the ditch to an eastward flowing direction and lining the ditch with half round HDPE pipe. The location of the ditch is ideal for both long term closure of the site and any future mining activity.
